June 12, 2013 Project No. 4929

RE: Historic Impoundment Level Considerations Moeckel Pond Dam NH Dam #256.08 Windham, New Hampshire

## Moeckel Pond Dam Historic Impoundment Level Considerations Windham, New Hampshire

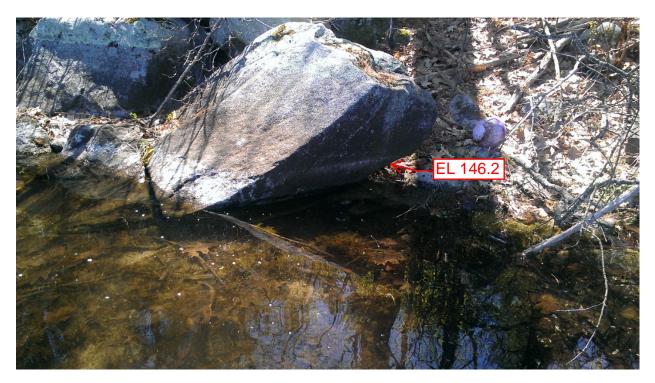
South east shoreline (first boulder)

Location	Object	Measuring Point	Elevation
Moeckel Pond:			
upstream of dam	various boulders	top of dark band	146.3±
left upstream of dam	shoreline	vegetation line	147.1±
Deer Leap	north boulder	top of dark band	147.5±
Deer Leap	south boulder	top of dark band	147.5±
Deer Leap	base of cliff	top of dark band	147.6±
Rock Pond:			
south east shoreline (refer to photo)	first boulder	top of dark band	146.2±
south east shoreline (refer to photo)	second boulder	top of dark band	146.2±
south east shoreline (refer to photo)	concrete wall	top of dark band	148.0±
north west shoreline (refer to photo)	first boulder	top of dark band	146.3±
north west shoreline (refer to photo)	second boulder	top of dark band	146.2±

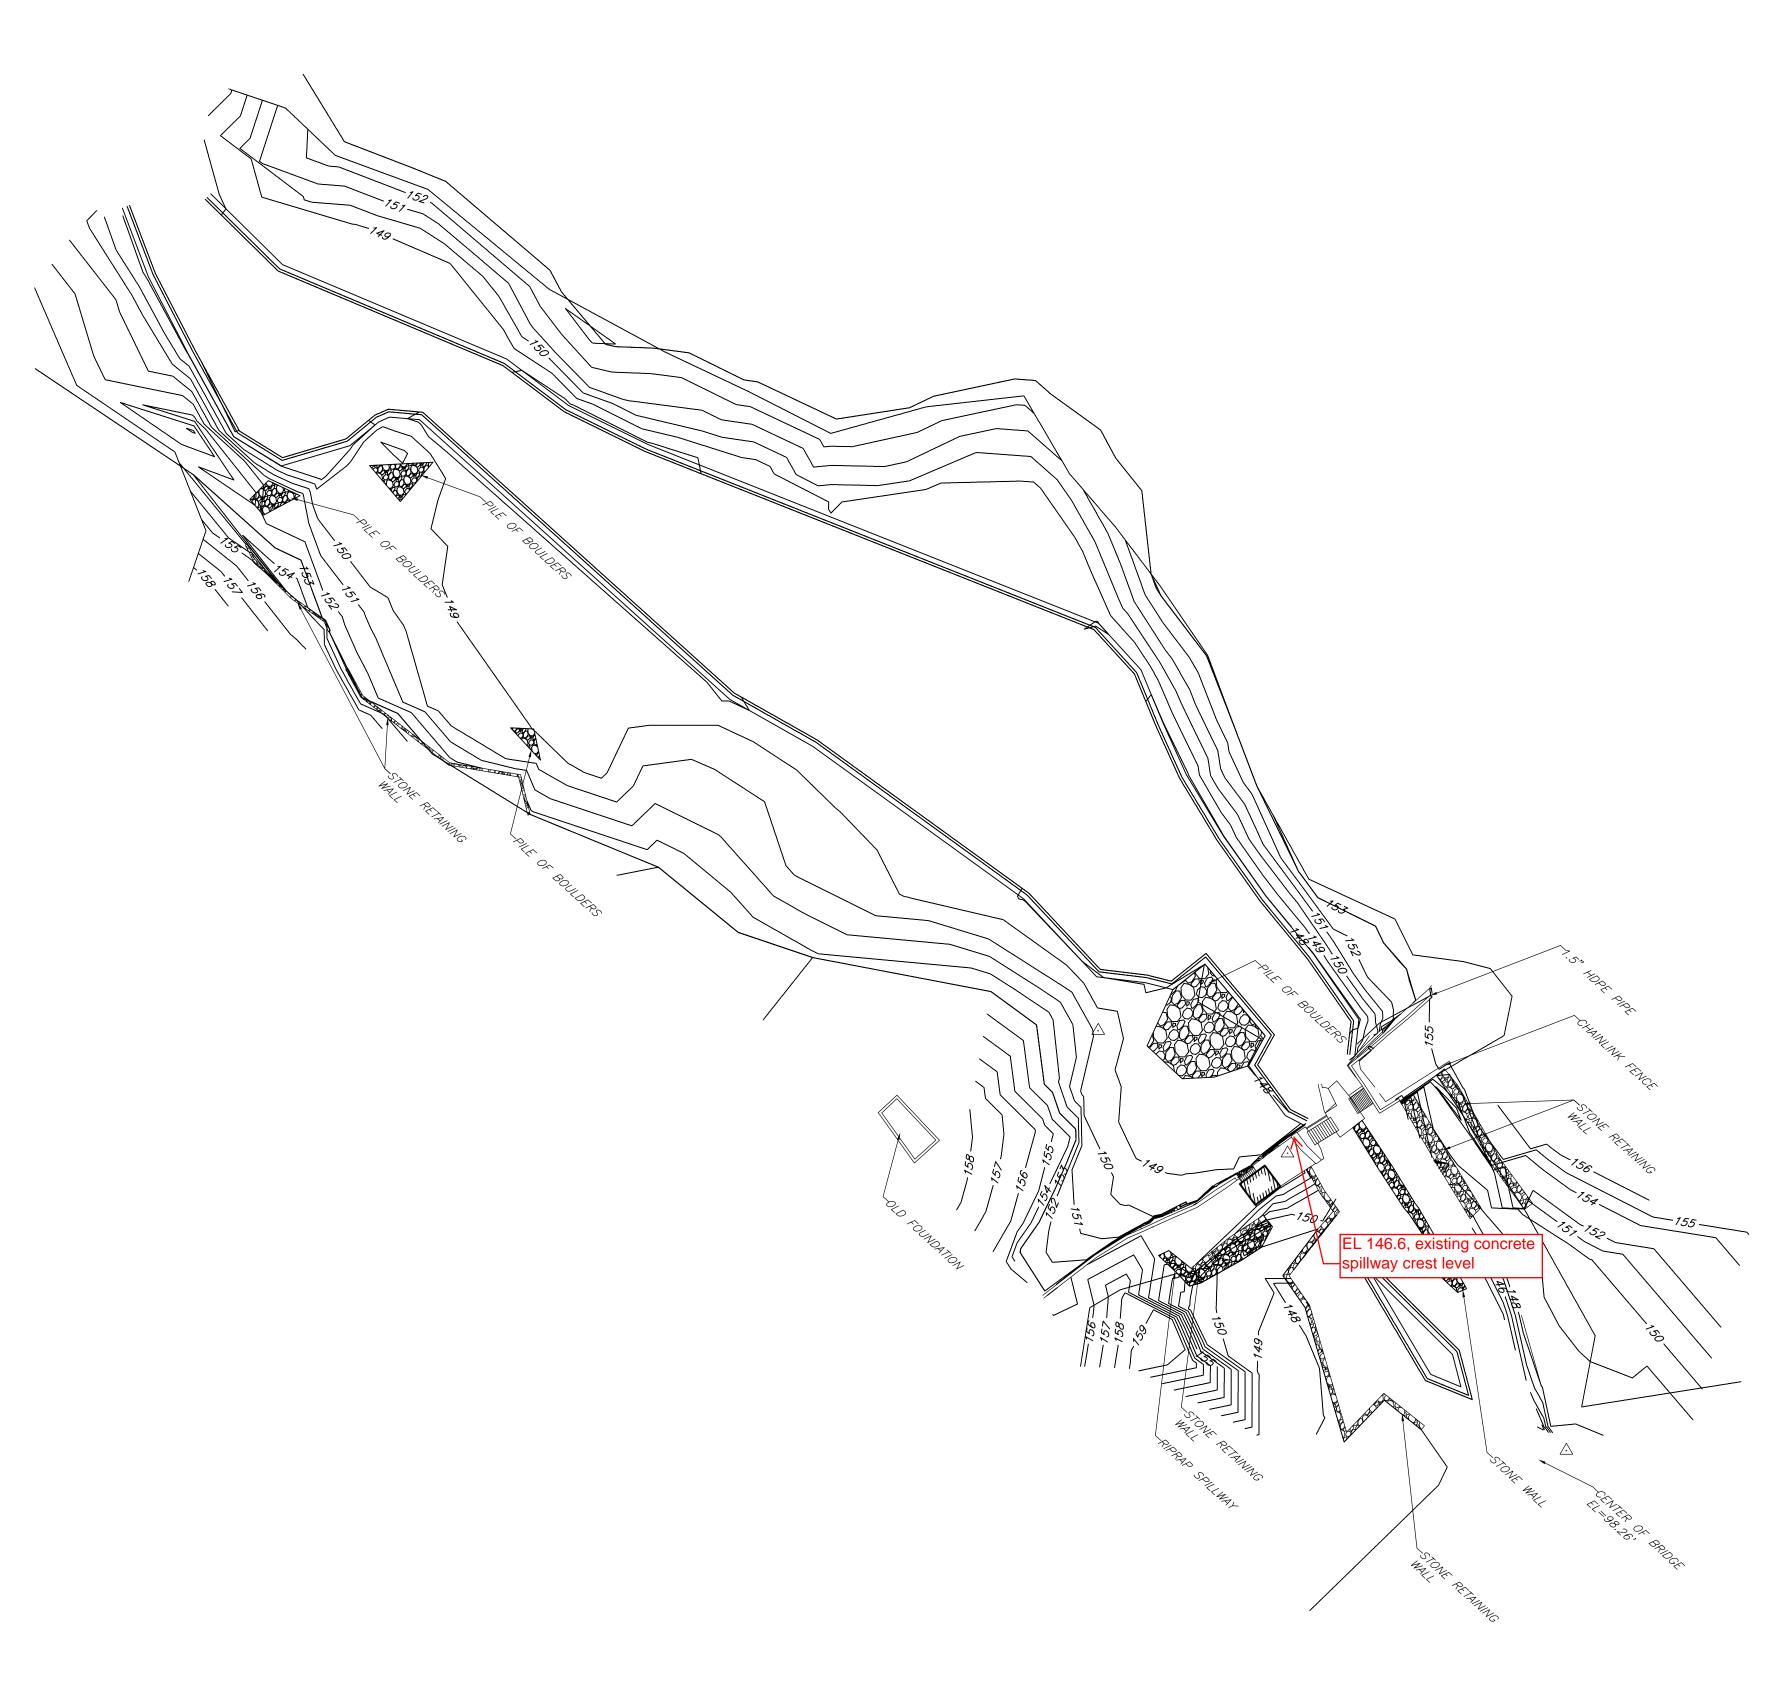
## FIGURE 1

Given the data presented above, it appears that the most recent historic impoundment level in Moeckel Pond would have been EL 146.6, the concrete spillway crest level (refer to the attached Figure 1). Given that there would have been significant variations in the impoundment level due to dry periods in conjunction with leakage through the dam, it can be expected that typical summer impoundment levels may have been below EL 146.6 provided that the former boards

In summary, HTE recommends proceeding with the H&H analysis and new spillway design using a historic spillway crest level of EL 146.6. Please review the data presented herein and let HTE know if you agree with our suggested permanent spillway level of EL 146.6. A soon as we obtain your approval of permanent spillway crest level, the next phase of the H&H analysis can commence. In the interim, please do not hesitate to contact me should you have any questions.
